*Installation power cable and Multiple
Casualty Accident
(3 deadly, 1 severely injured)*

26th August 2013

*THE „MYSŁOWICE-WESOŁA” UNDERGROUND COAL
MINE in MYSŁOWICE in SILESIA AREA, POLAND*

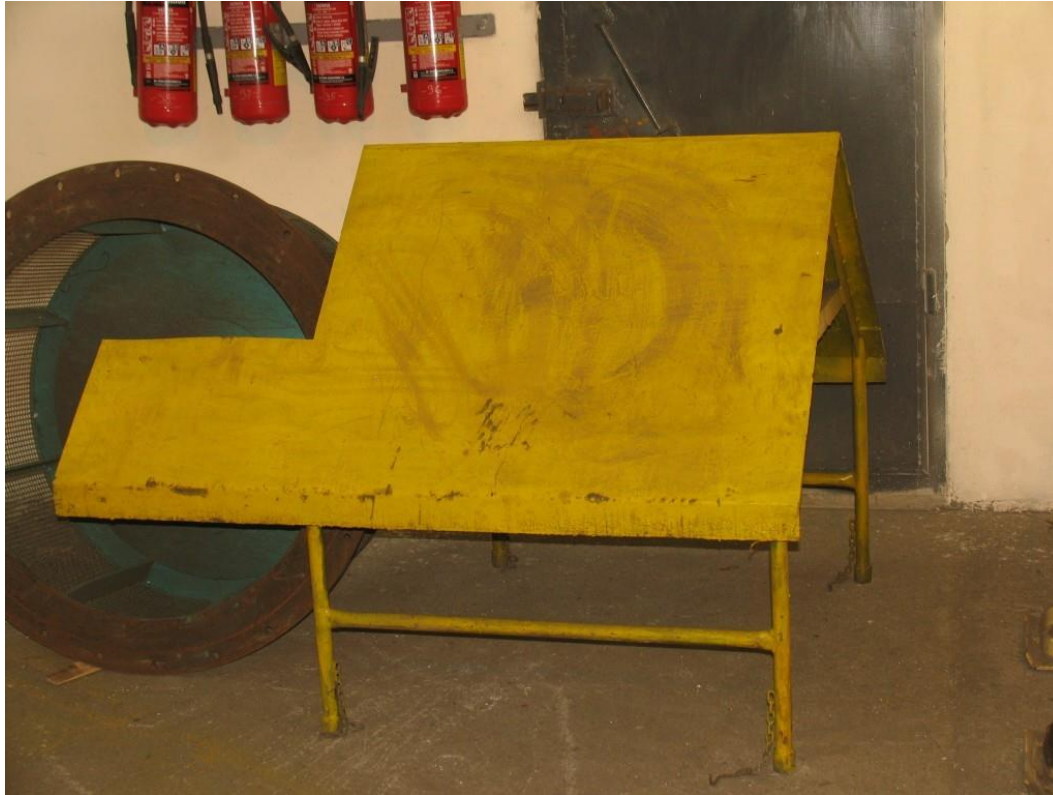
Protective roof

- defective cable holders - uncontrolled movement of the cable,
- holders was load weight of the cable and rope,
- not suitable protective roof (14x),
- lack of awareness of risks.

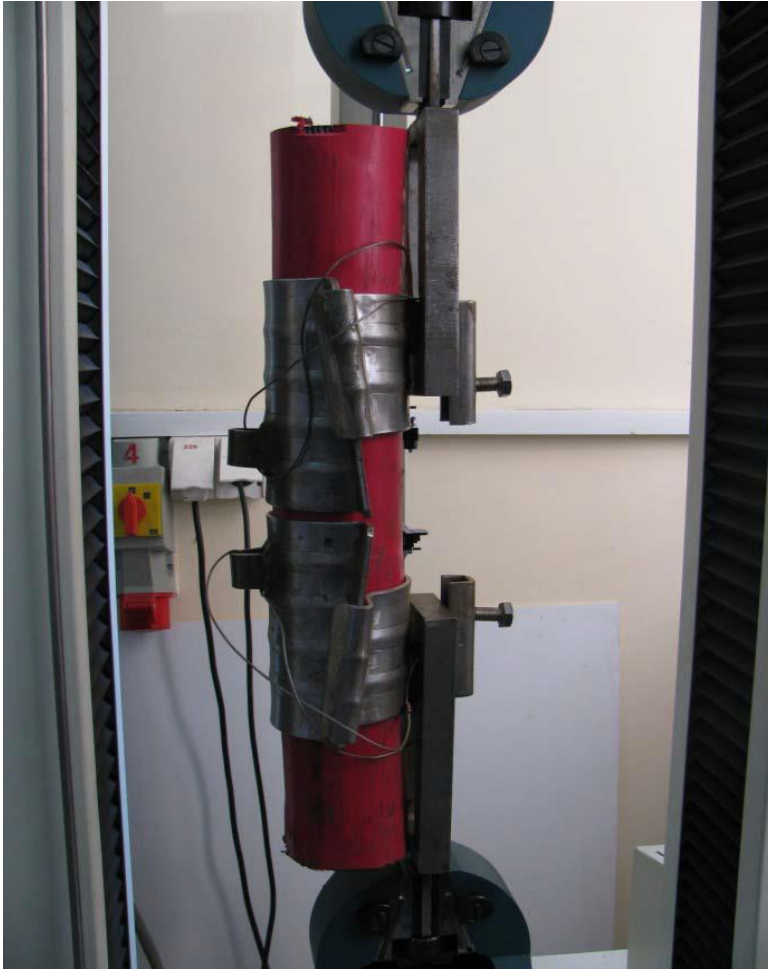
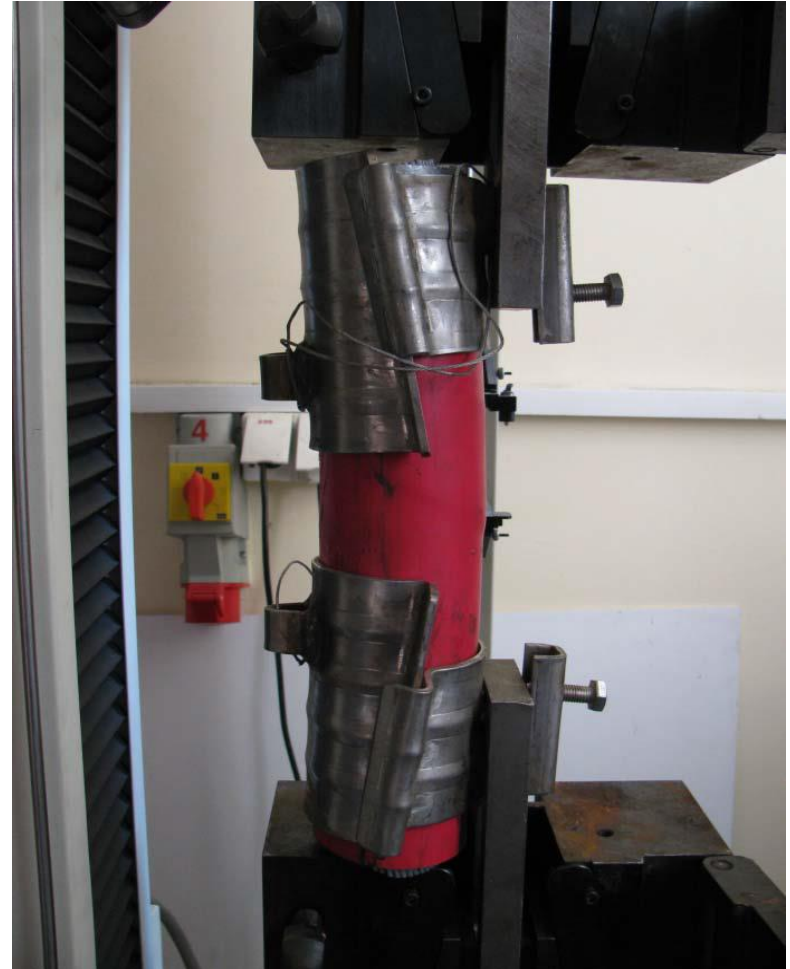
Characteristics cable holder

- producer – **CARBOMECH Ltd. Company**
- typ – **3-211.2**
- diameter of cable – **74÷83 mm**
- load allowable/maximum – **933 /2880 kG (9150/27458 N)**
- weight – **1,59 kg**
- product material - **stainless steel X6CrNiTi18-10 (1.4541)**
- load - $6\text{m} \times 16,21 \text{ kg/m} \times 9,81 \text{ m/s}^2 = 954 \text{ N}$
- test load - **1200÷6013 N (average 3887 N)**
