ELECTRICAL INSTALLATIONS NATIONAL CONGRESS AND EXHIBITION
IZMIR 2023

ACOUSTIC CAMERA SI124

PARTIAL DISCHARGE AND LEAK DETECTION

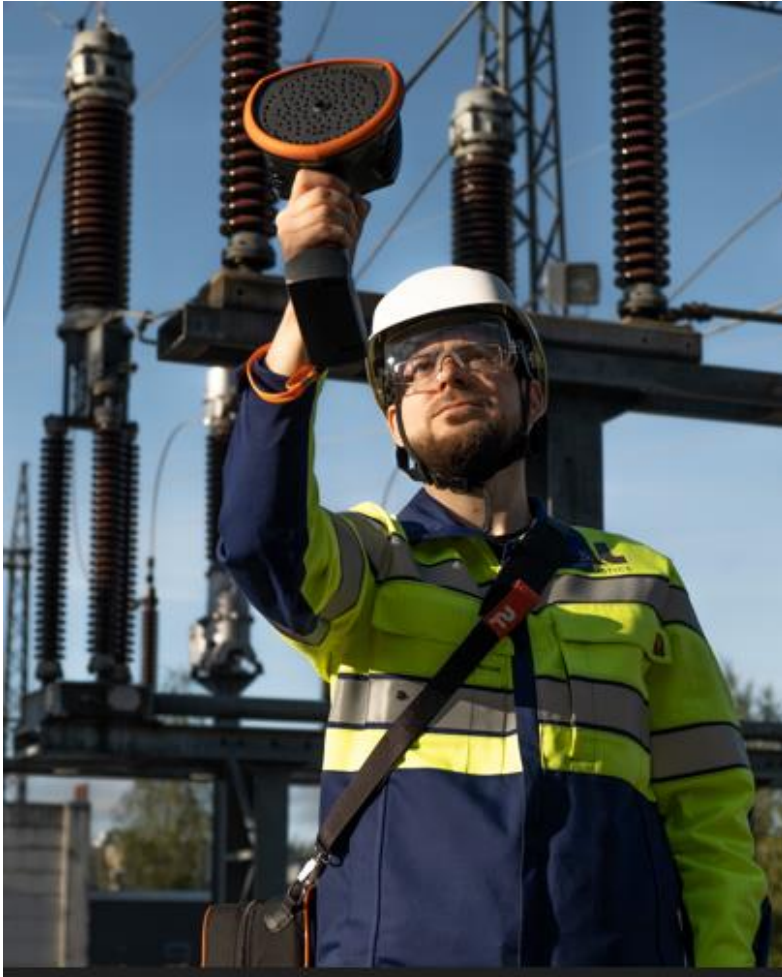
BENEFITS OF THE SI124-PD

- Prevents expensive downtime and catastrophic failures through early-stage PD detection.
- Scans large areas from a distance and instantly pinpoints critical problems.
- Provides actionable data for maintenance and repairs plans with the help of machine-learning powered analytics.
- Simple to incorporate to the maintenance cycle and requires minimal training.
- Safe and easy to operate using only one hand.

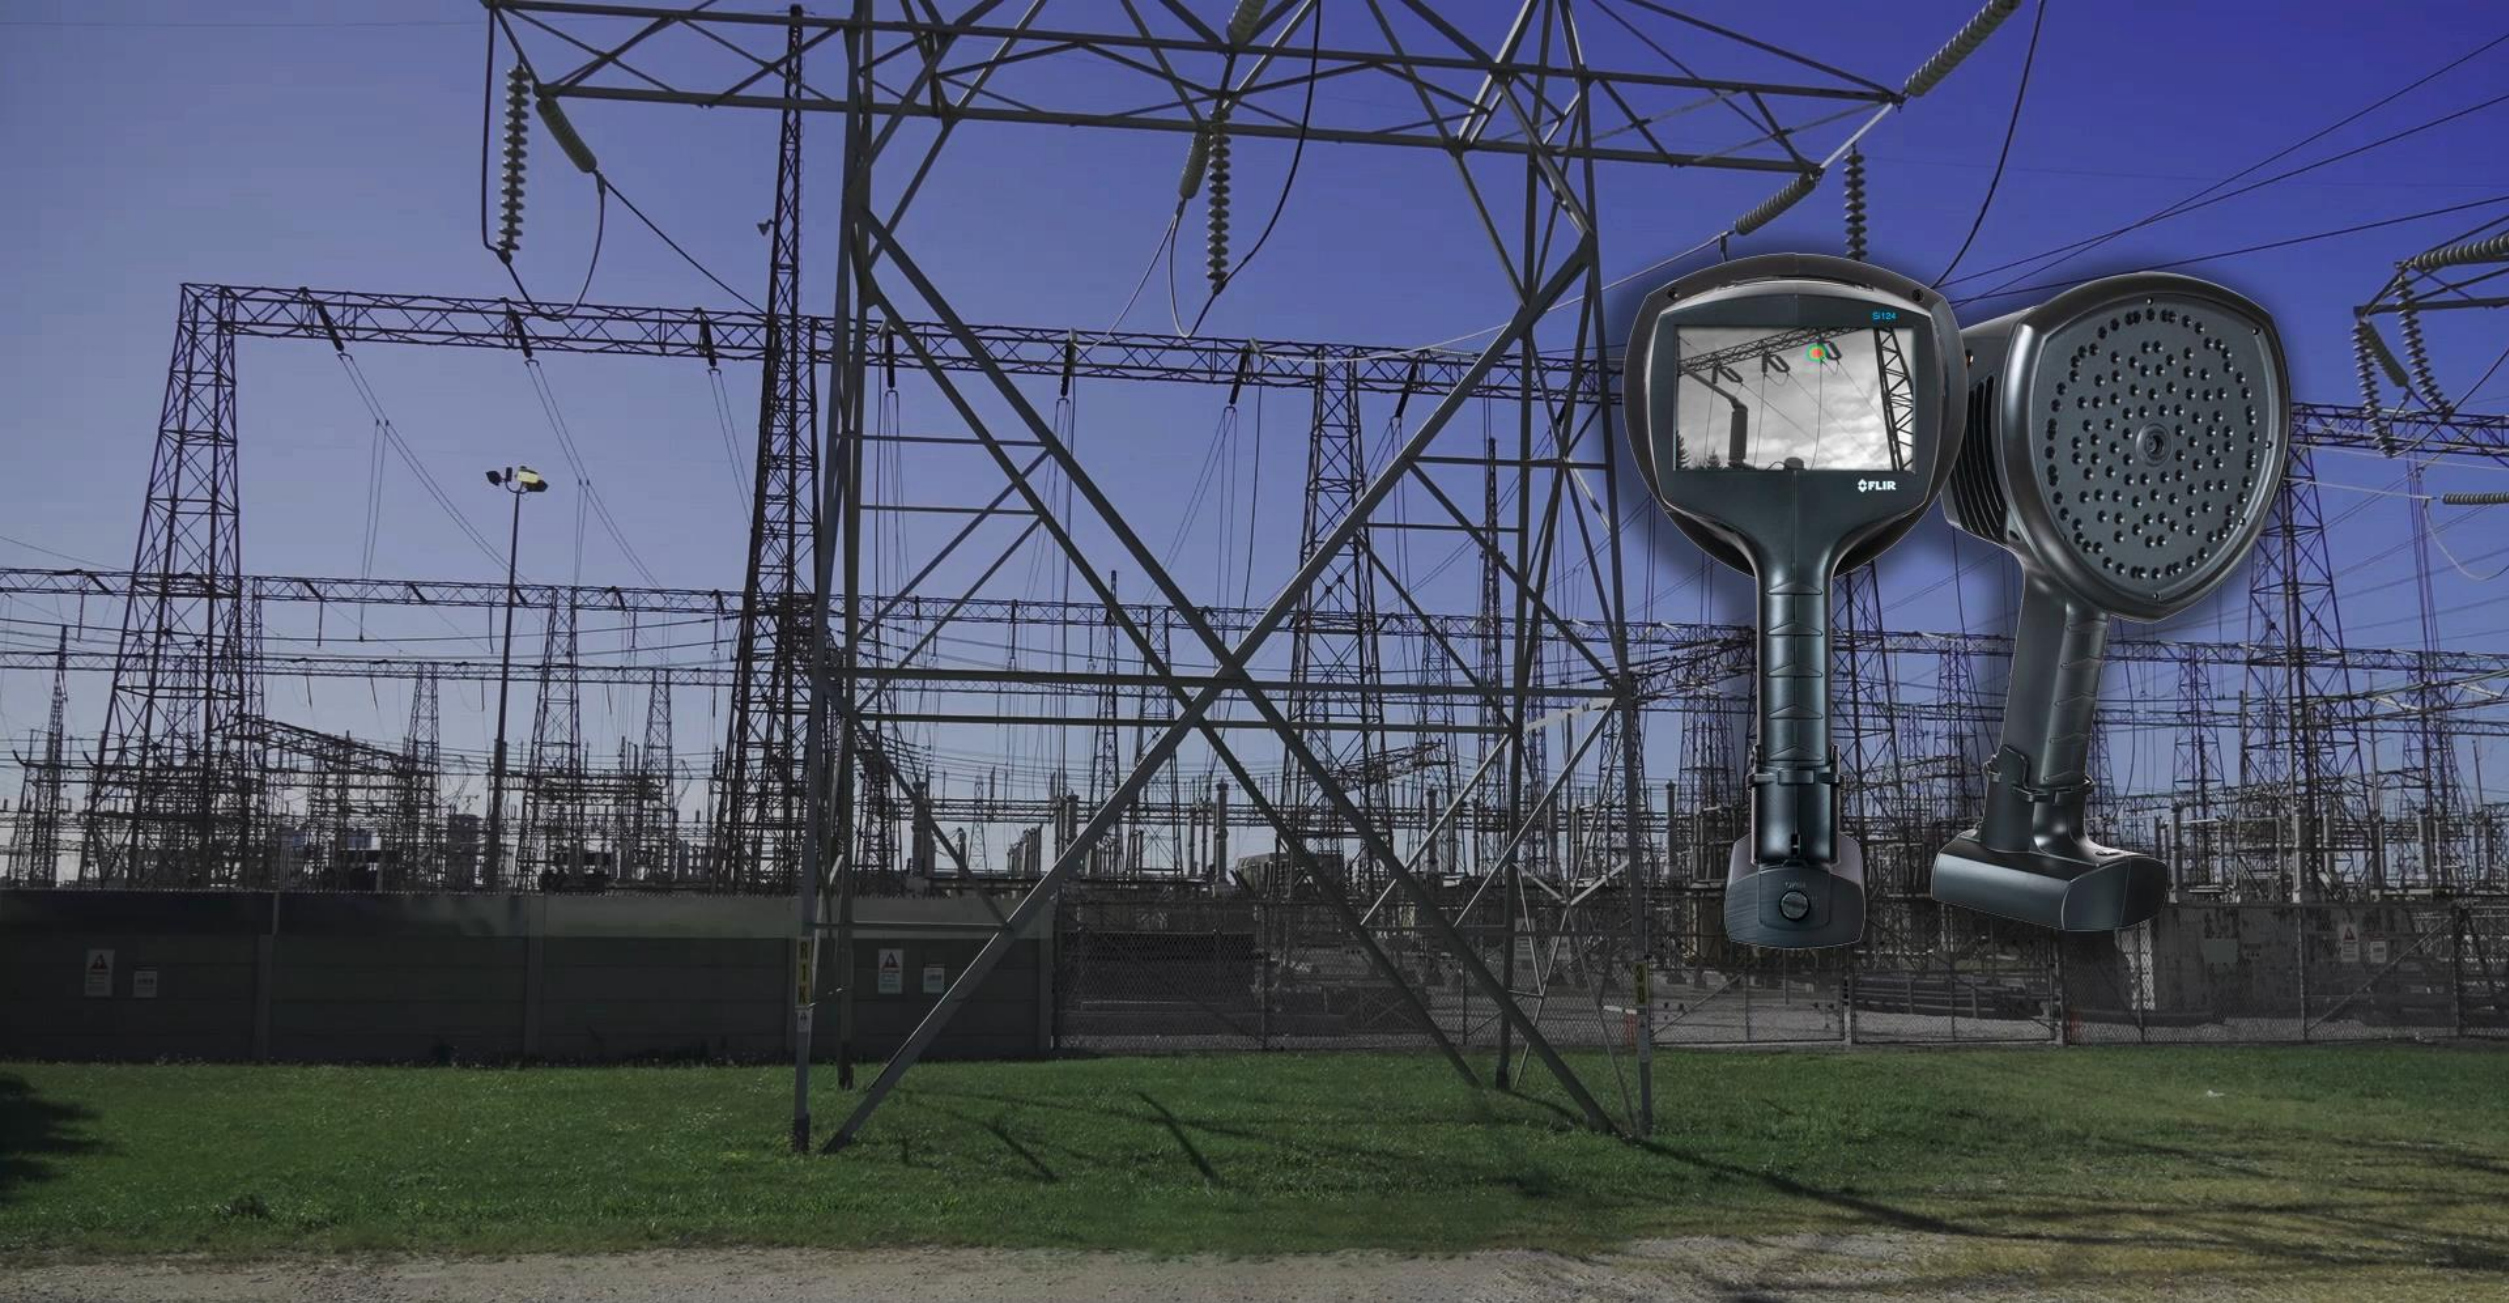
OPERATING THE SI124-PD

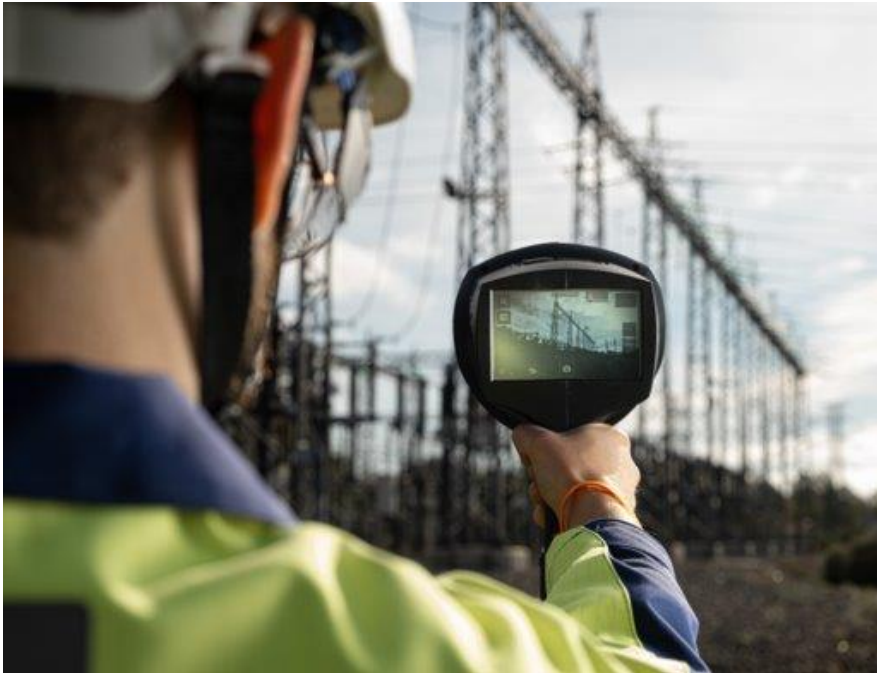
- In multi-source mode, the Si124-PD always shows analytics for the strongest sound source, for closer analytics, use single-source mode
- Reflections: if the source moves when moving the camera, it is a reflection
- Hidden sound sources: the camera can show sound sources inside cabinets and other closures when the sound finds its way out
- Filters: the camera's operating distance is greater outdoors where there is rarely high-frequency background noise and where PDs usually occur:
 - Norm (2–30 kHz): The best alternative for all cases with little background noise. Offers the best detection distance.
 - High (20–30 kHz): Offers good detection distance while filtering out most background noise.
 - Ultr (30–65 kHz): Effectively filters out background noise at the expense of reduced detection distance. Only to be used at short distances.

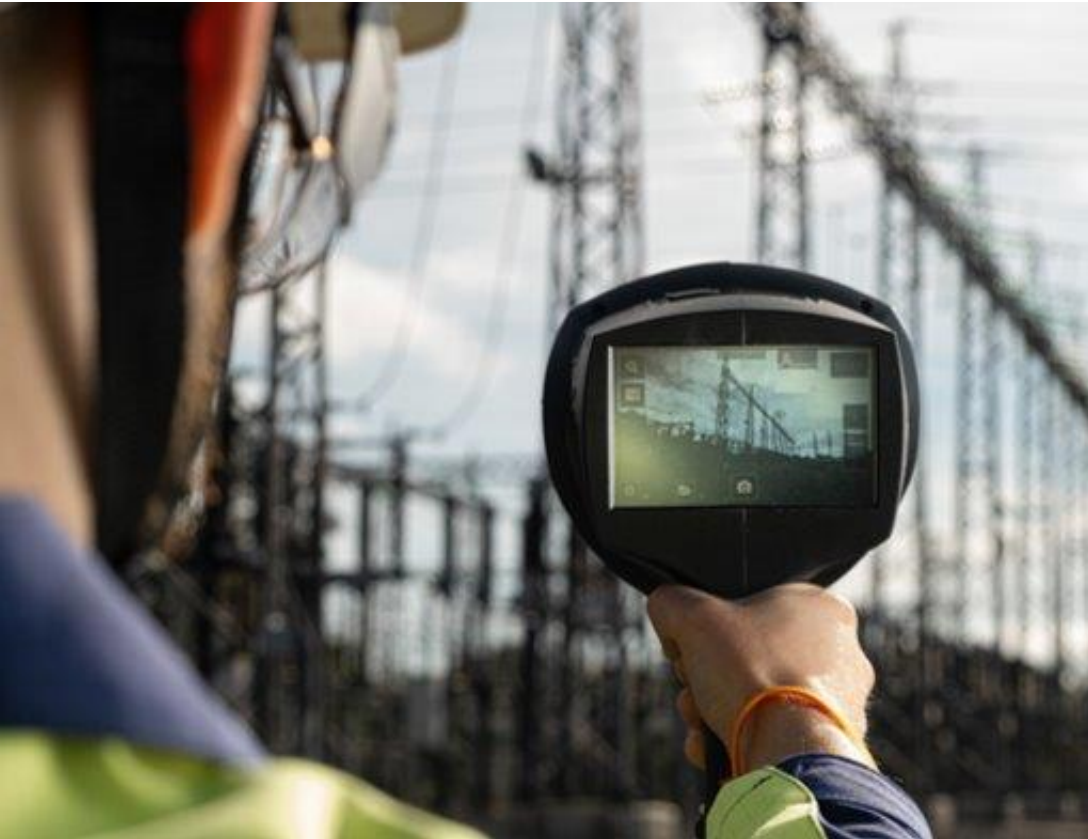
- Recognizes the sounds partial discharges emit and distinguishes them from other sounds, discarding all the non-relevant noise
- Reliably pinpoints partial discharges and shows their exact location clearly on the screen
- Automatically displays the PD pattern when a partial discharge is located
- Presents the sound pressure (dB) level that also indicates the strength and stage of the partial discharge

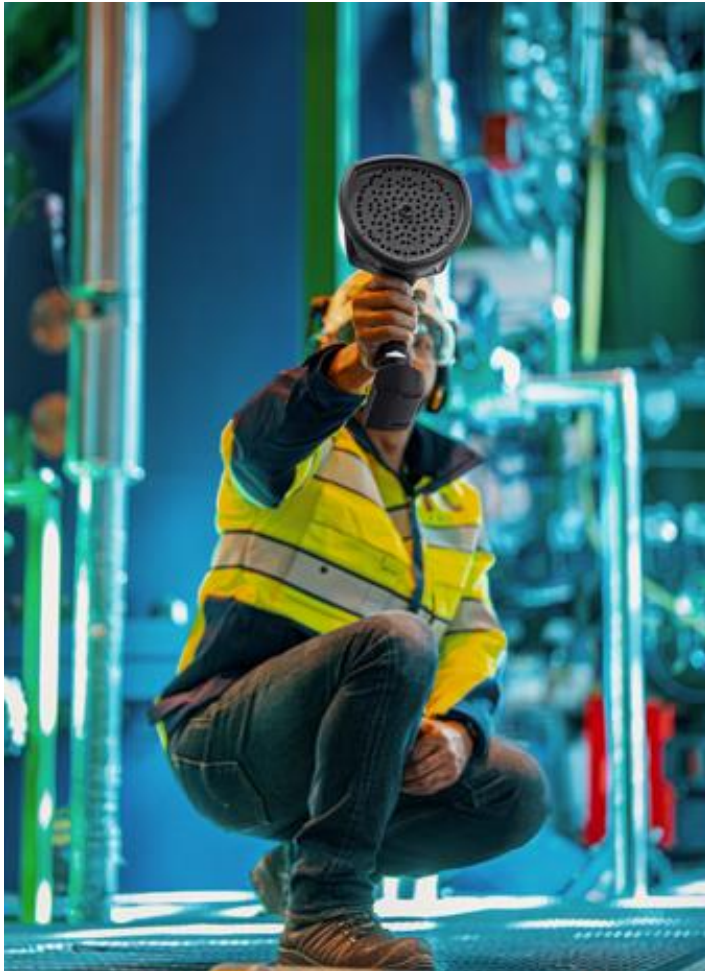
BENEFITS OF THE SI124-LD PLUS

- **AutoDistance:** automatically detects the distance between the leak and camera
- **AutoFilter:** automatically filters out disturbances in noisy, high decibel environments

- Shows the exact location of leaks and leak size and cost estimate: helps lower overall production costs
- Pinpoints leaks as small as **0.004 l/min**
- **Faster and more accurate** than other leak detectors and methods

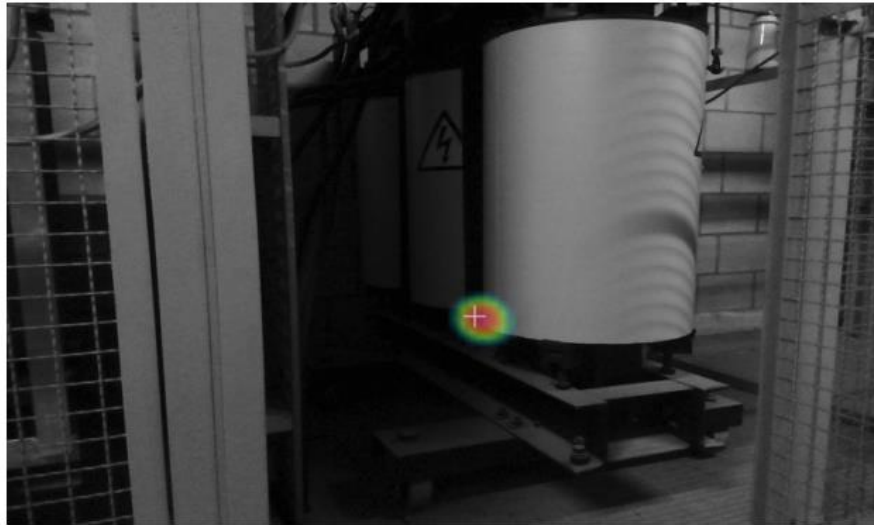
Description
This is classified as a surface or internal discharge. The discharge appears to be strong and might rapidly escalate to complete insulation breakdown.

Recommendation
Immediate action. Visual inspection. Cleaning of polluted surfaces. Repair or replacement of the components.

Level	25.9 dB
Date created	20.10.2022
Device	AC130093
Device Label	AC130093_00017_221020_1 231_0017
Distance	2 m
Voltage	10 kV
Location	transformer

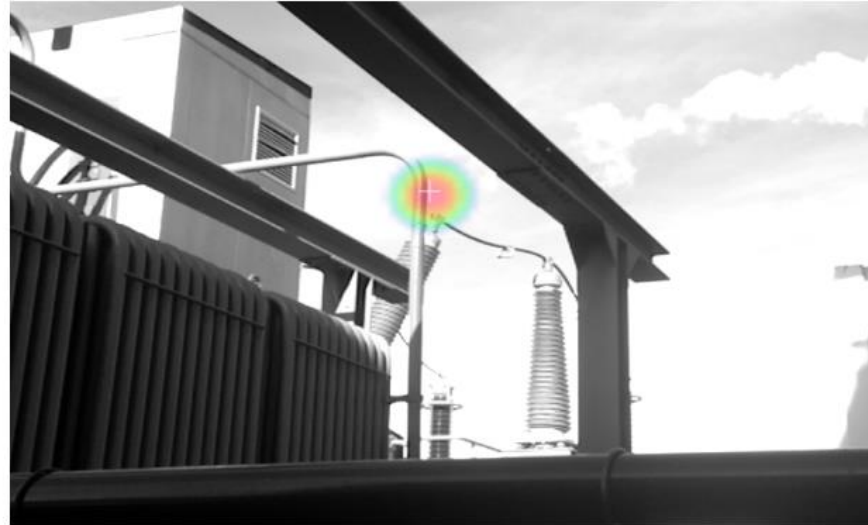
Description
This is classified as corona, i.e., partial discharge into air. In most cases, corona is harmless.

Recommendation
Typically no action required unless power loss, audible noise, electromagnetic interference, or deterioration of nearby polymer insulators is a problem.

Level	4.3 dB
Date created	19.10.2022
Device	AC130093
Device Label	AC130093_00009_221019_1 301_0009
Distance	10 m
Voltage	150 kV
Location	bushing

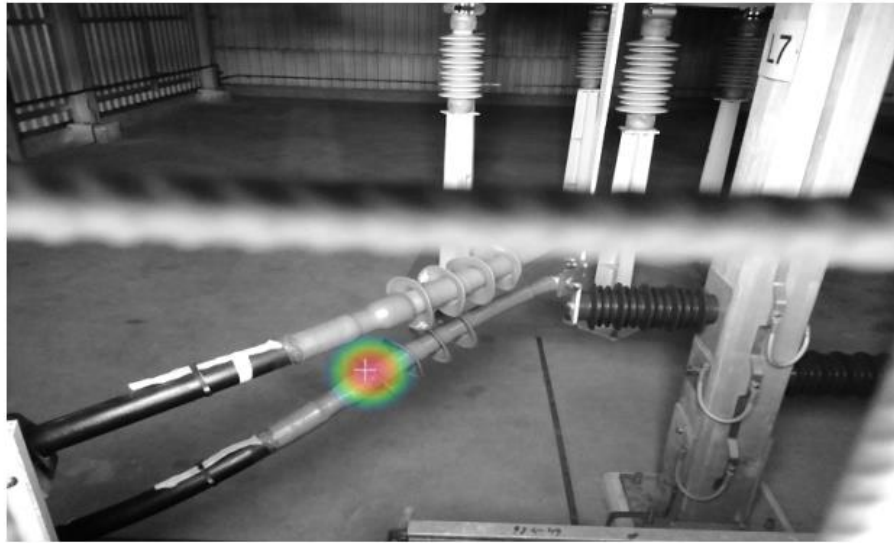
Description
This is likely to be a strong surface or internal discharge. Surface or internal discharges on cables, terminations, and joints will progress over time and might rapidly escalate to insulation breakdown.

Recommendation
Visual inspection. Cleaning of polluted surfaces. Repair or replacement of damaged components.

Level	7.6 dB
Date created	19.10.2022
Device	AC130093
Device Label	AC130093_00005_221019_1249_0005
Distance	2 m
Voltage	35 kV
Location	cable termination

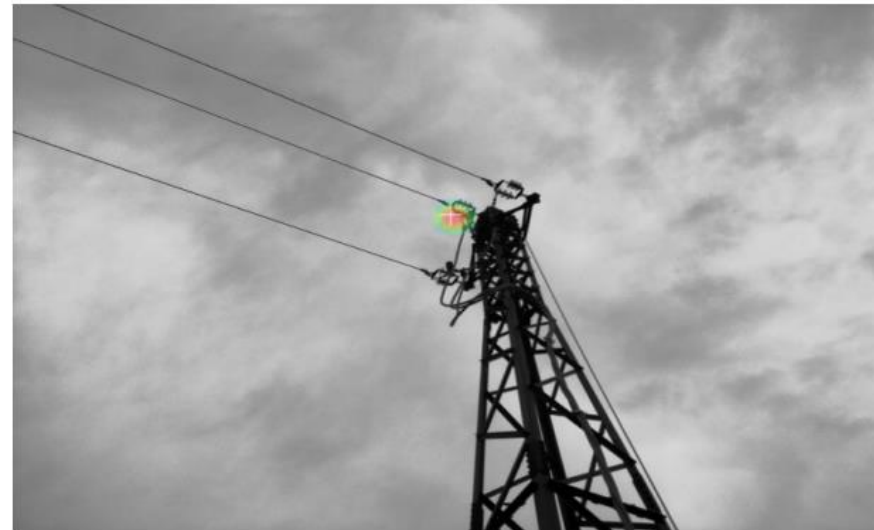
Description
This is classified as a surface or internal discharge. The discharge appears to be strong and might rapidly escalate to complete insulation breakdown.

Recommendation
Immediate action. Visual inspection. Cleaning of polluted surfaces. Repair or replacement of the components.

Level	10.4 dB
Date created	30.9.2022
Device	AC130092
Device Label	AC130092_00096_220930_1142_0096
Distance	15 m
Voltage	15 kV
Location	polymer suspension insulator

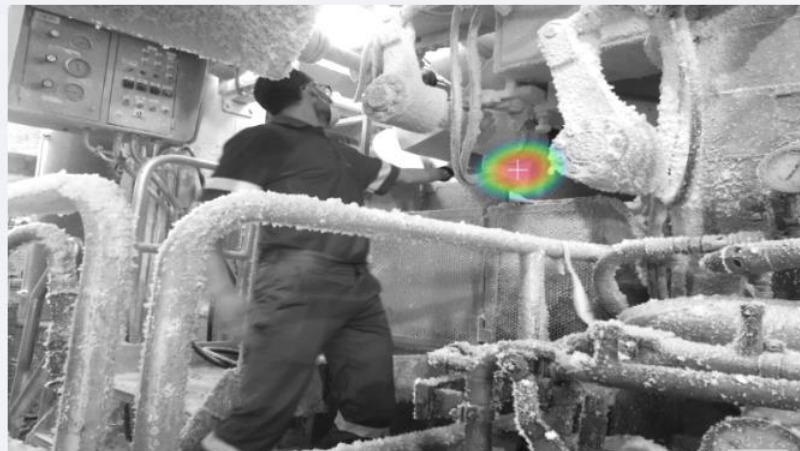
Distance

4

Estimated leak size: 58 l/min

Estimated annual cost: 828 € / year
