THERMOGRAPHY APPLICATIONS FOR ELECTRICAL INSTALLATIONS IN BULIDINGS

Binalarda Elektrik Tesisatı Sempozyumu 18 Ekim 2019, Cuma // Saat : 12.10-12.30

T.P.SINGH

FLIR Systems

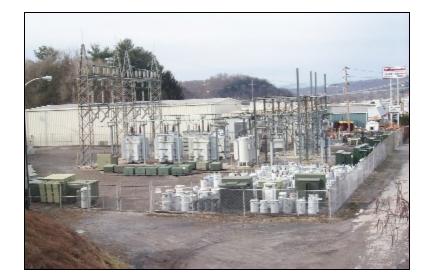
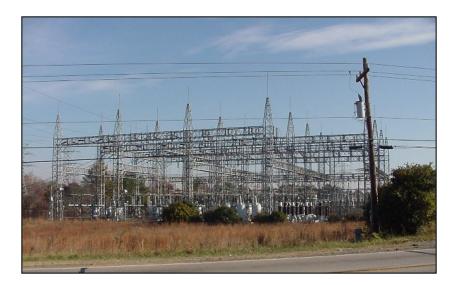
Online-Electrical Substations

- Isolated, often unmanned
- Remote monitoring
- No lighting

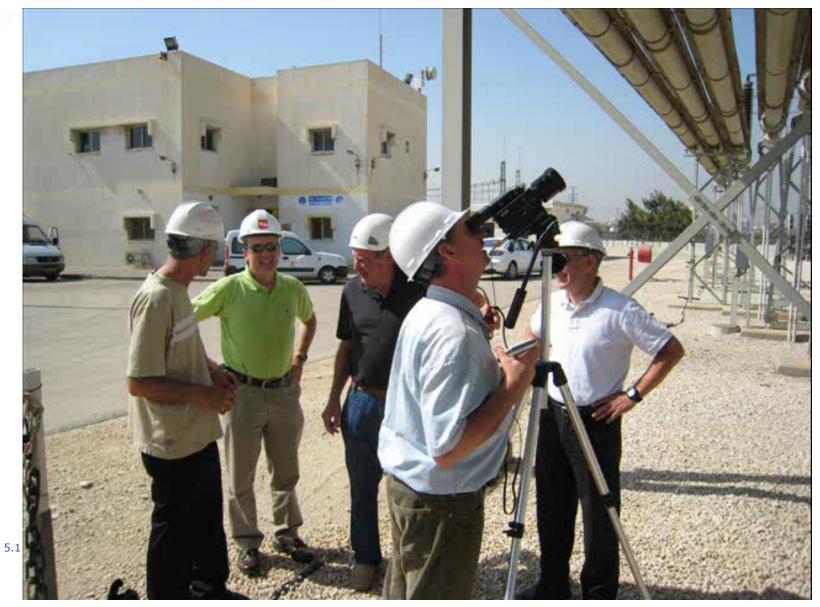
Leakage Visualisation

Gas Leakages

Many chemical compounds and gases are invisible to the naked eye.

•Earlier methods of gas detection required close or near contact using "sniffer" technology and probes. The limitations of these methods are that they are time consuming and run a risk of missing gas leaks. They may expose inspectors to invisible and potentially harmful chemicals.

•The Gas Detection cameras are infrared cameras which are able to visualize gas.

•The camera produces a full picture of the scanned area and leaks appear as smoke on the camera's viewfinder. The image is viewed in real time and can be recorded in the camera for easy archiving. 5 c iv /6
